Office of Oversight
Independent Technical Review of
**Argonne National
Laboratory-West
Radiation
Contamination Incident**

December 1998

Office of Environment, Safety, and Health

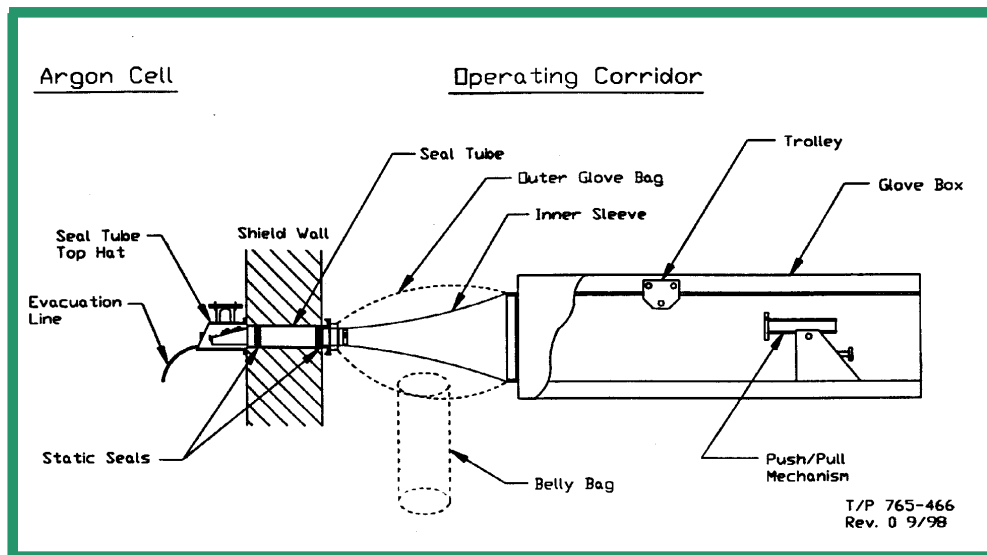
Schematic of the Seal Tube and Glovebox: The plastic outer glove bag and inner sleeve serve as the containment between the glovebox and shield wall. The seal tube is extracted from the shield wall through the inner sleeve and into the glovebox for maintenance.

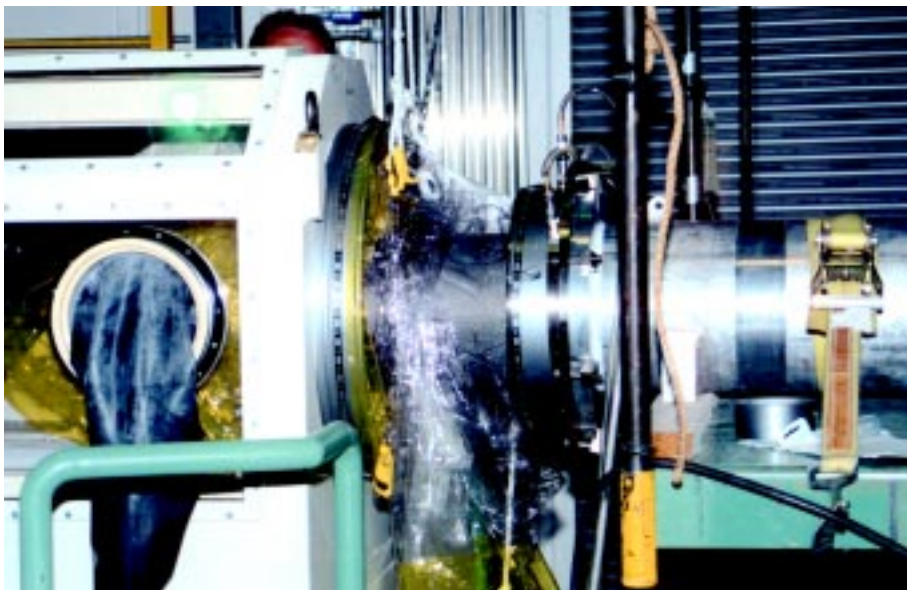
Mockup of Containment: This is a mockup showing the connection of the bagging ring and glovebox together to conduct work on the seal tube.

The hazard analysis for the maintenance activity was not clearly documented during preparation for the work on the seal tube. This is evident in the lack of appropriate personnel dosimetry and lack of contamination monitoring around the seal flange. Pre-job radiation surveys were not conducted in preparation for the work. Instead, historical contamination levels were used to complete the radiation work permit (RWP), and this did not translate into appropriate personnel dosimetry until after the job began and the actual radiation levels were obtained. While the three procedures used to conduct the work provided several precautions about monitoring for contamination, they did not specifically identify the bagging ring as a potential source. The focus of the precautions relates directly to tears and rips that could develop in the plastic used between the bagging ring and the glovebox.

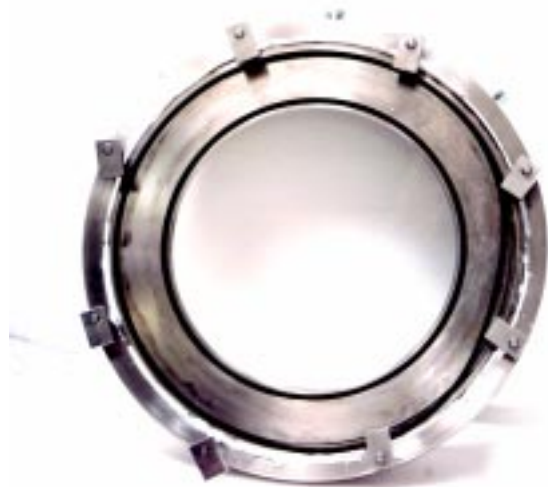
The direct cause of this event was improper installation of the bagging ring. Contamination surveys performed after the event indicated significant contamination between the surfaces of the flange face and the bagging ring. Operation of the glovebox at a positive pressure with respect to the operating aisle subsequently caused the

Bagging Ring: The bagging ring attaches to the cell wall to permit installation of the plastic containment. Shown is the seating surface with O-rings and J-bolts.

An unreviewed safety question determination was not performed before the design changes to the bagging ring assembly were implemented in early 1997. Unreviewed safety question determinations are required for facility modifications that could impact the safety basis of the facility. Furthermore, the modification to the bagging ring was accomplished without using the approved engineering procedures that control the design changes for nuclear-related equipment. Consequently, the modifications did not receive any additional independent design reviews. The responsible engineer independently determined that the bagging ring was a quality Level-C component, and was thus exempt from the engineering design procedure. This engineering design procedure provides for exceptions for modifications that are “simple and inexpensive QA Level-C tasks.” However, the procedure does not provide thresholds or guidance for determining which tasks are “simple and inexpensive.” The redesign of this bagging ring, due to the machining and materials involved and consequences of failure, should have been subject to the requirements identified in the engineering design procedure that would have resulted in more extensive reviews and approvals.

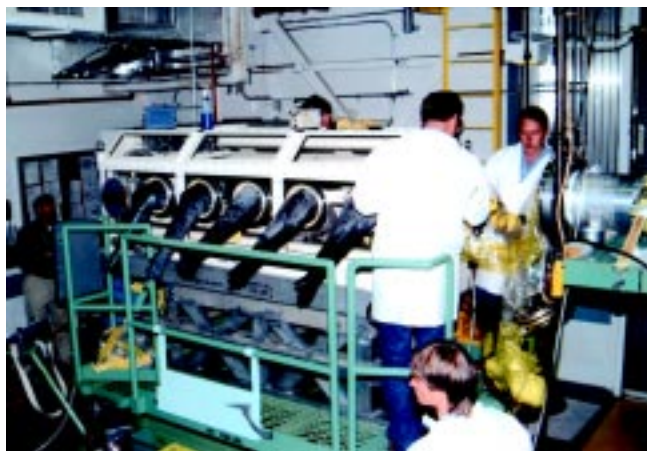
Glovebox Assembly: Workers in lab coats conduct a walkthrough of the seal tube repair on a mockup. Note the extension of the glovebox gloves, indicating a positive pressure with respect to the area that the workers occupy.

In the event at the FCF, the work was performed in accordance with the established procedures except for pressure control within the temporary containment. The outer containment was inflated above the limits specified in the maintenance procedure. In addition, the outer containment sleeve was at a positive pressure with respect to the operating aisle. An improperly installed bagging ring, coupled with positive pressure in the containment, is believed to have caused the release.
